Herritage 'finger' way-posts

Survey for West Chiltington Parish Council June 2016 – D Weaver

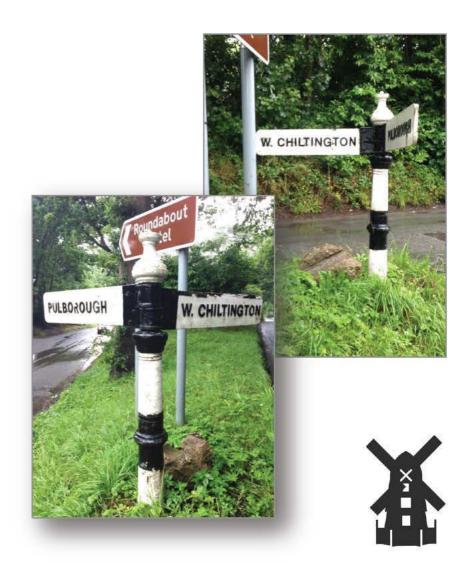
Rock Cottage

The iron work is in good order and seems mostly original. There are a lot of evidence of rust but this can be rectified with a clean and cosmetic repaint providing it is addressed within the next year. The ring finial is the original 'ROUNDABOUT' design.

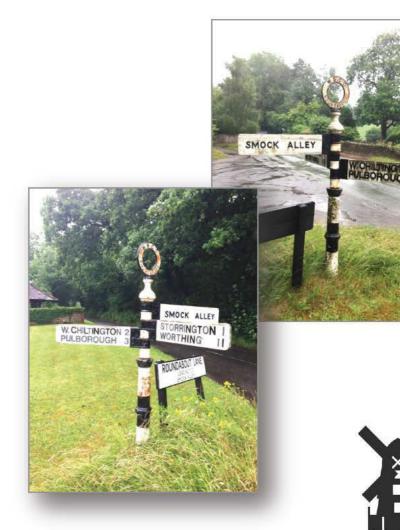
West Chiltington Common

| BOARD | D TEXT DIMENSIONS (mm) | | REMARKS |
|---|--|---|---|
| 8.1 | The Village 1 Coolham 5 Horsham 12 | 900 x 300 | Split - Repair/Replace |
| 8.4 | Storrington 3 Worthing 12 | 900 x 190 | Split - Repair/Replace |

Close inspection shows multiple signs of damage and subsequent repair. The the current bowl is concrete and the structural integrity is provided from a scaffold pole inserted to the centre of the post. Brackets no longer move independently. Rust patches require curing and repainting. Cosmetic Repainting needed. The ring finial is post 1950's design 'W CHILTINGTON'

Plastic lettering has been used to replace metal characters on the sign boards this has broken in places.

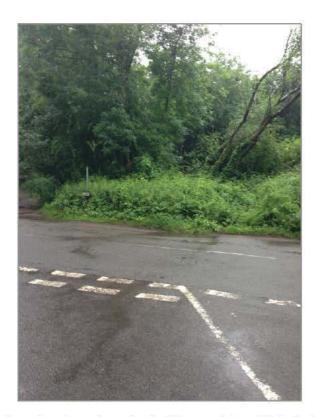
Location of previous sign (looking south from Nytimber)

| BOARD | TEXT | DIMENSIONS (mm) | REMARKS |
|---|---|---|---|
| 9.1 | W Chiltington 1 Horsham 12 | 900 x 300 | Missing |
| 9.2 | Storrington 2 | 900 x 190 | Missing |
| 9.3 | Petworth 9 Pulborough 3 | 900 x 190 | Missing |

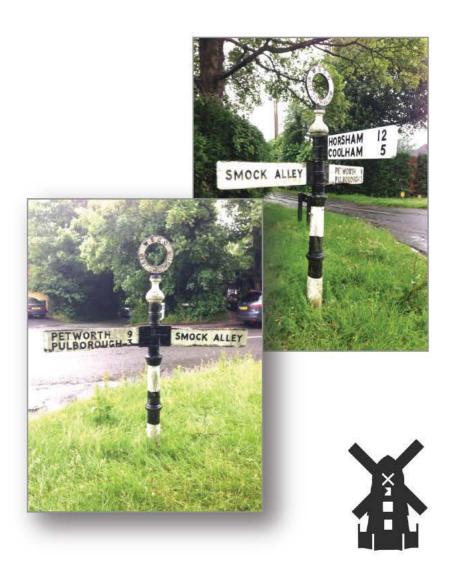
Nytimber / The Common

| BOARD | TEXT | DIMENSIONS (mm) | REMARKS |
|---|---|---|---|
| 10.2 | Smock Alley | 900 x 190 | Rotten - Repair/Replace |
| 10.3 | Pulborough 3 Petworth 9 | 900 x 190 | Rotten - Repair/Replace |

Good original condition thouth some maintenance is needed to ensure the sign remains preserved. There is evidence of rust and some 16 coats of paint much of which needs to be blasted back before further repainting is attempted. Suggest removal of boards and errectsoda blast in situ. The ring Finial is 1930's design 'WEST CHILTINGTON'

Sign is well preserved and all the ironwork seems original and correct. Attention is required to preserve the sign, especially with regard to repainting of the iron work. Lead is undoubtedly present in the lower coats of pain hence caution needs to be taken. May be possible to soda blast in situ. Immediate action is needed in order to preserve this sign.

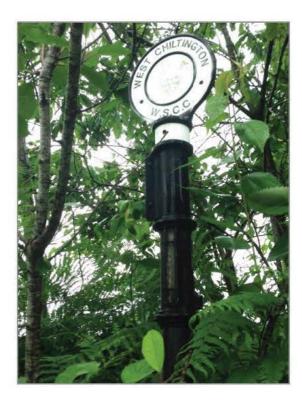
Stream Lane / Gay Street

The original iron post has been replaced with a steel pole. The sign has been fitted with a modern aluminium cast finial with the county coat of arms printed on (this has now worn away)

Location of sign has overgrown considerably. All boards have broken off. Construction of sign not really intended for rural use. Needs replacement.

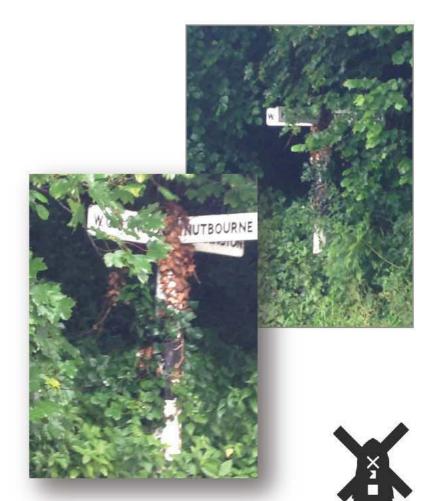
Windmill

None - Post is oak and is mostly sound however there are signs of rot at the base. The extent that the post is able to move indicates this rot may already be quite advanced. The mortice joints seem very sold and well sealed, though ivy growth has started to effect the join to the 'Nutborne' board. The cast iron top cap is missing.

The sign is greatly obscured by overhanging foliage (as evident in the pictures). Attention is required to reinforce the rotten base.

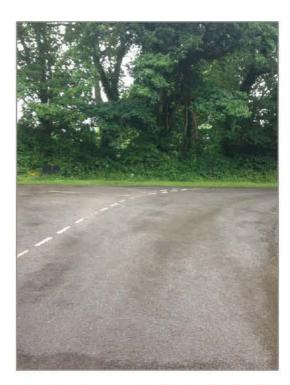
Location of previous sign (Looking East for Gay Street Ln)

| BOARD | TEXT | DIMENSIONS (mm) | REMARKS |
|---|---|---|---|
| 13.1 | W Chiltington 2 Gay Street | 900 x 200 | Missing |
| 13.2 | Adversane 2 North Heath | 900 x 200 | Missing |
| 13.3 | No Through Road | 900 x 200 | Missing |
