# Heritage 'Finger' Way-Posts

Survey for West Chiltington Parish Council  
June 2016 – D Weaver

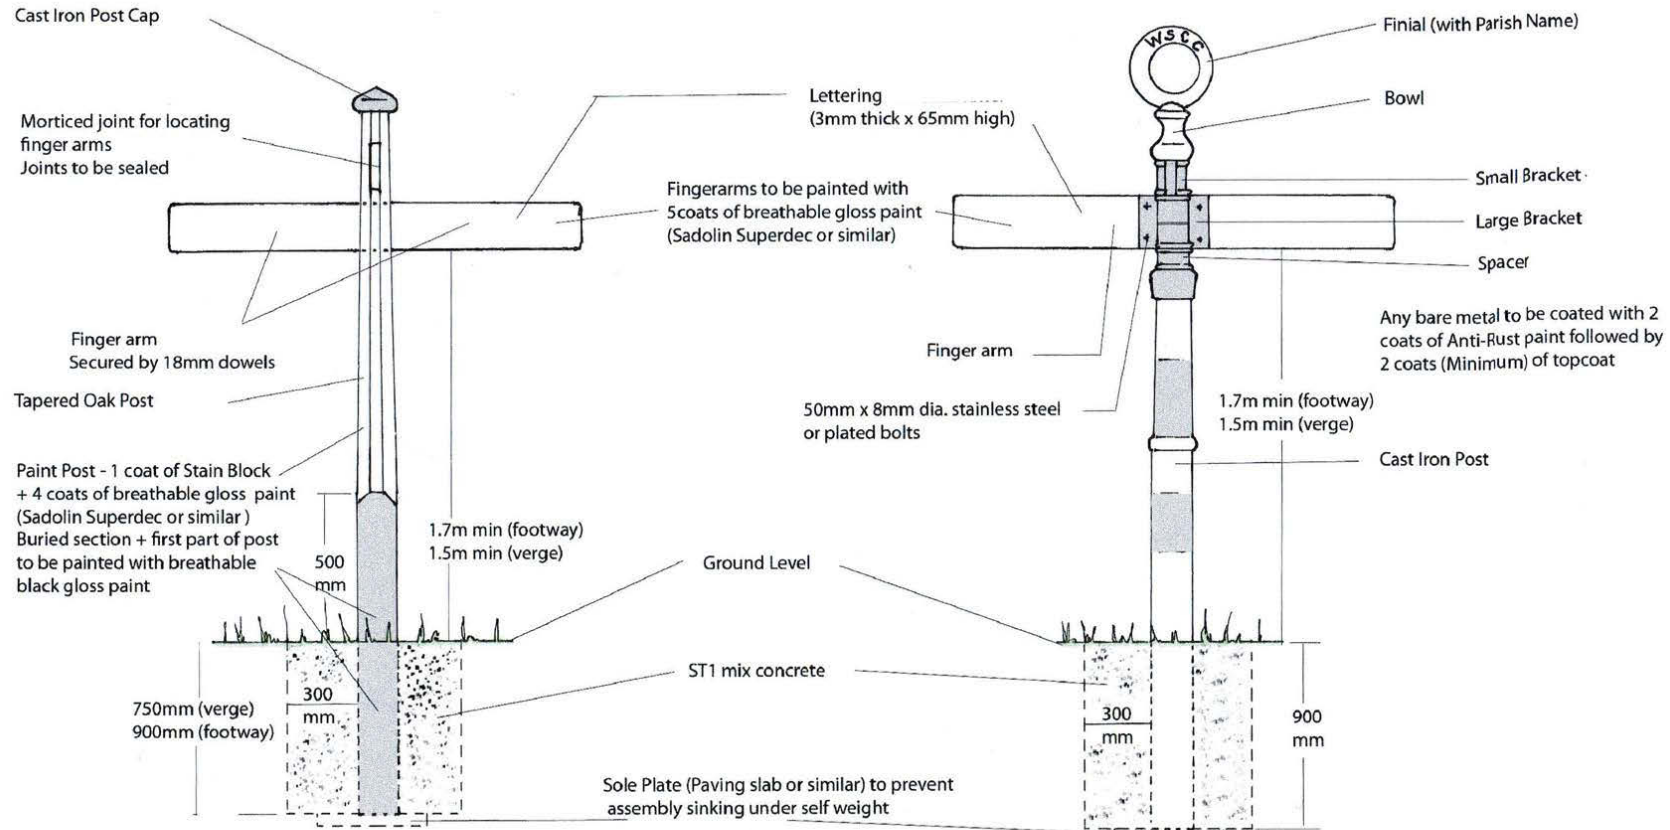
# Types and anatomy of Way-post

**East Sussex Style  
(Wooden)**

**West Sussex Style  
(Cast Iron)**

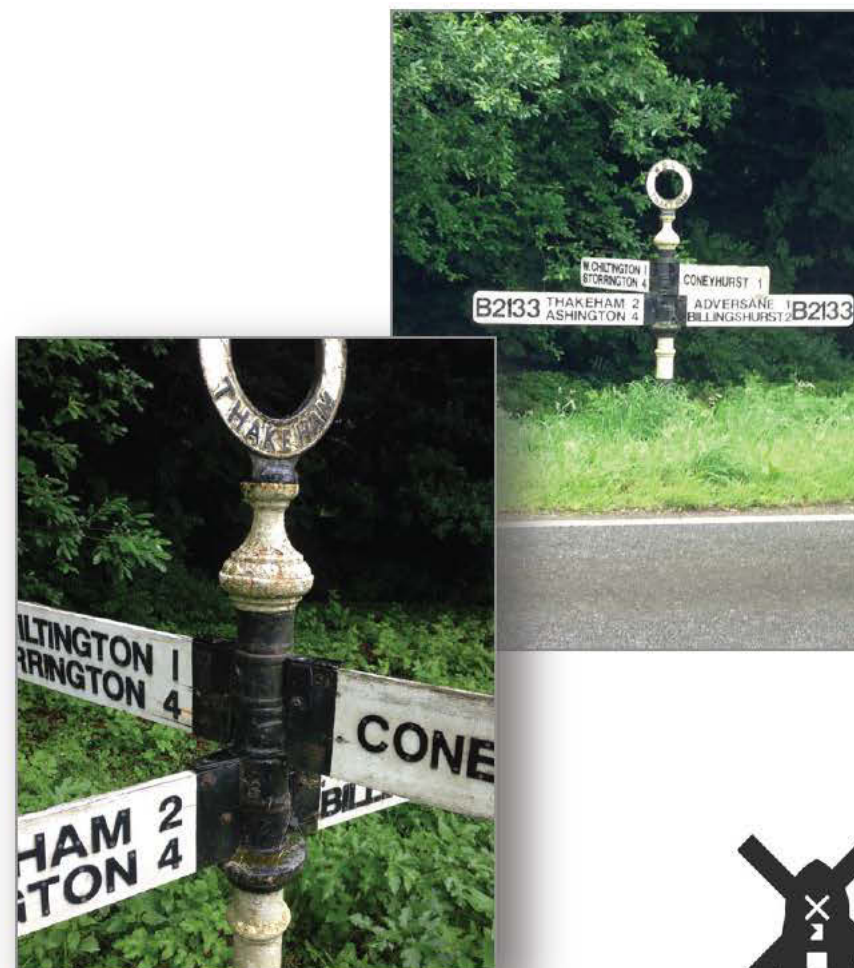
## #2

### B2133 – Broadford Bridge

TYPE Pole marker

BOARD	TEXT	DIMENSIONS (mm)	REMARKS
2.1	W. Chiltington	900 x 155	Sound - 'W' missing from one side

The original iron post has been replaced with a steel pole which now shows signs of rust therefore as cosmetic clean and repaint will be required within the next 2 years. The sign has no ring finial but is capped.

Sign is not original and is now largely redundant as larger modern signs have been placed to enhance visibility of the junction.

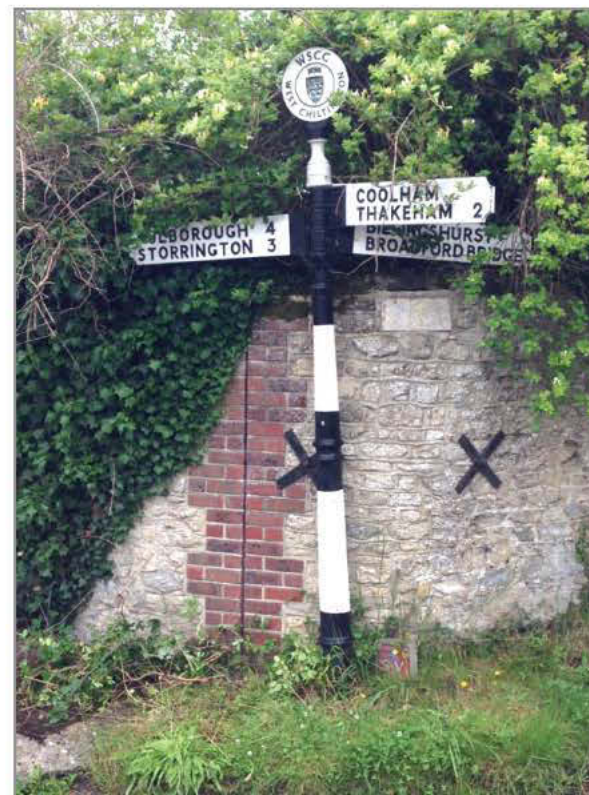
# #4

## Sinnocks

TYPE Prewar Cast Iron

BOARD	TEXT	DIMENSIONS (mm)	REMARKS
4.1	West Chiltington 1 Nutborne 2 Pulborough 3	900 x 300	Sound - Repaint
4.2	Smock Alley 1 Roundabout 2 Storrington 3	900 x 300	Sound - Repaint
4.3	Thakeham 2 Coolham 4 Horsham 10	900 x 300	Sound - Repaint

The iron work is in good condition but would benefit from a cosmetic clean and repaint within the next year. The ring finial and bowl were unscrewed and are missing - records show 1930's 'WEST CHILTINGTON' finial was previously fitted.

Plastic lettering has been used to replace metal characters some of which are broken.

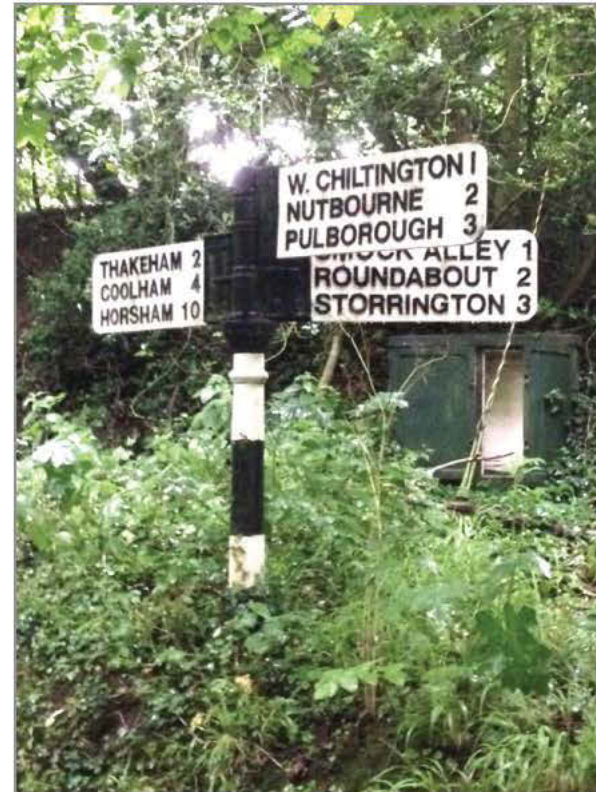
# #5

## Monkmead / Harborough Hill

TYPE Prewar Cast Iron  
BOARDS 3

BOARD	TEXT	DIMENSIONS (mm)	REMARKS
5.1	Washington 5 Storrington 2 Roundabout 1	900 x 300	Sound - Repaint
5.2	Smock Alley West Chiltington	1000 x 200	Rotten - Repair/Replace
5.3	Petworth Pulborough	770 x 190	Sound - Repaint

The iron work is in good order and seems mostly original. There are minor signs of rust, the sign would therefore benefit from a clean and cosmetic repaint in the next year. The ring finial is 1950's 'W CHILTINGTON' type.

This sign has been well maintained the rot of the 'Smock Alley' board is the most obvious need of attention

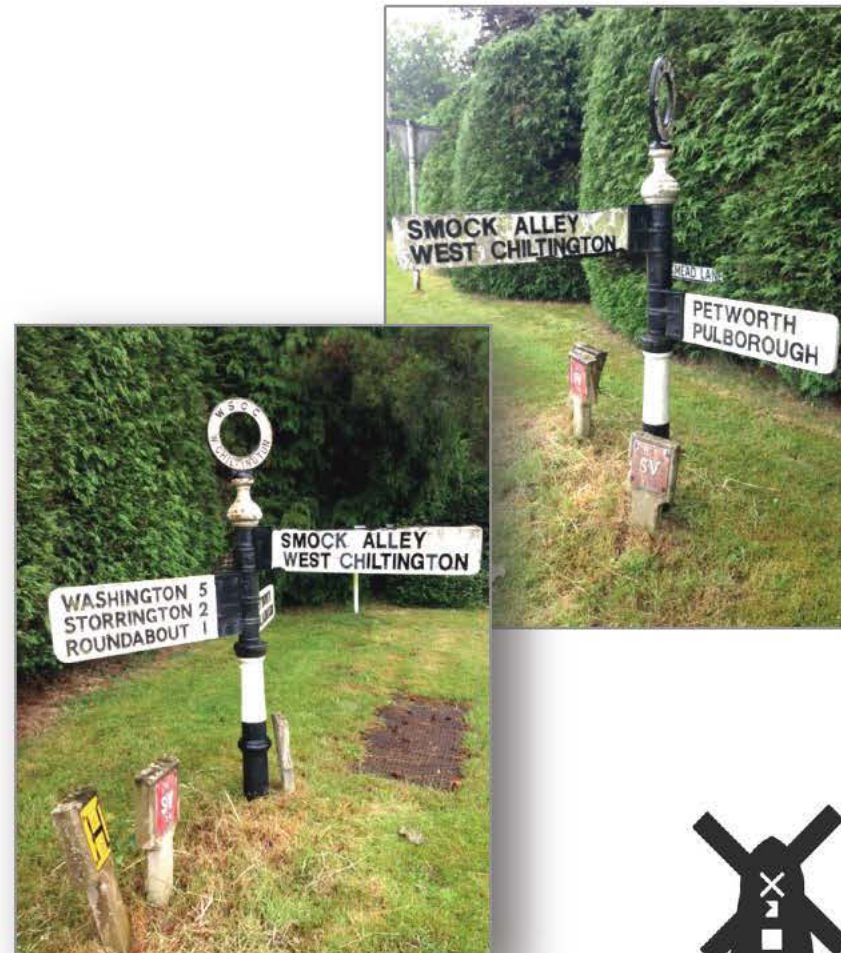
# #6

## Monkmead / Common Hill

TYPE Prewar Cast Iron  
BOARDS 2

BOARD	TEXT	DIMENSIONS (mm)	REMARKS
6.1	W. Chiltington	200 x 900	Rotten - Repair/Replace
6.2	Pulborough	200 x 900	Sound - Repaint

The iron work is in good condition but would benefit from a cosmetic clean and repaint within the next year. The ring finial has been broken off and is missing. The bowl remains.

The precarious location makes maintenance here more difficult than most.

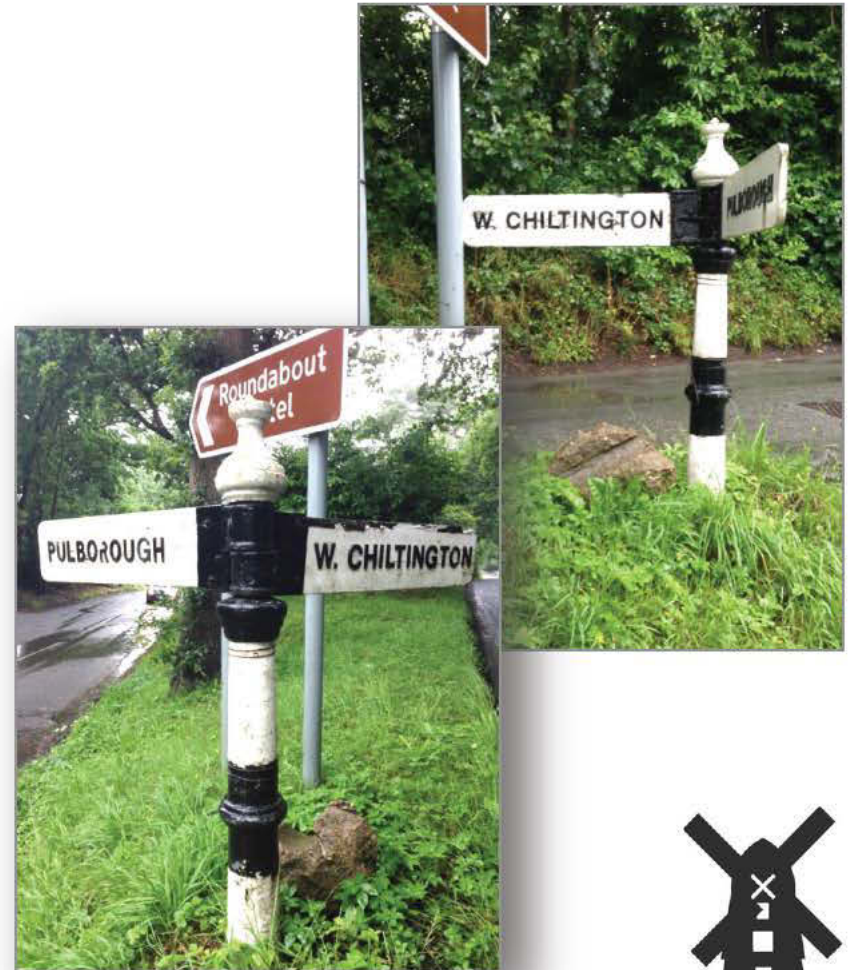
# #7

## Rock Cottage

TYPE Prewar Cast Iron  
BOARDS 3

BOARD	TEXT	DIMENSIONS (mm)	REMARKS
7.1	W. Chilmington 1 Pulborough 3	900 x 200	Sound - Repaint
7.2	Smock Alley	900 x 200	Sound - Repaint
7.3	Storrington 1 Worthing 11	900 x 200	Sound - Repaint

The iron work is in good order and seems mostly original. There are a lot of evidence of rust but this can be rectified with a clean and cosmetic repaint providing it is addressed within the next year. The ring finial is the original 'ROUNDABOUT' design.

This sign is one of the most prominent and most admired. It is seen by everyone entering the village from the south.

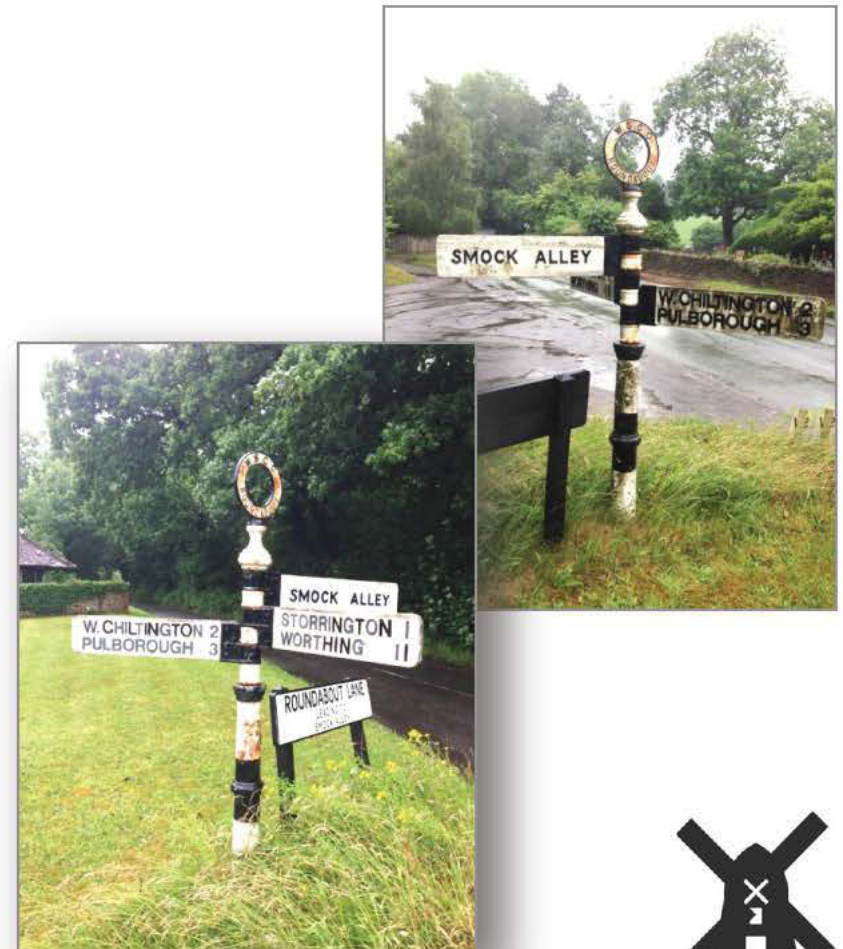
# #8

## West Chiltington Common

TYPE Prewar Cast Iron  
BOARDS 4

BOARD	TEXT	DIMENSIONS (mm)	REMARKS
8.1	The Village 1 Coolham 5 Horsham 12	900 x 300	Split - Repair/Replace
8.2	Smock Alley	900 x 190	Sound - Repaint
8.3	Pulborough 3 Petworth 9	900 x 190	Sound - Repaint
8.4	Storrington 3 Worthing 12	900 x 190	Split - Repair/Replace

Close inspection shows multiple signs of damage and subsequent repair. The the current bowl is concrete and the structural integrity is provided from a scaffold pole inserted to the centre of the post. Brackets no longer move independently. Rust patches require curing and repainting. Cosmetic Repainting needed. The ring finial is post 1950's design 'W CHILTINGTON'

Plastic lettering has been used to replace metal characters on the sign boards this has broken in places.

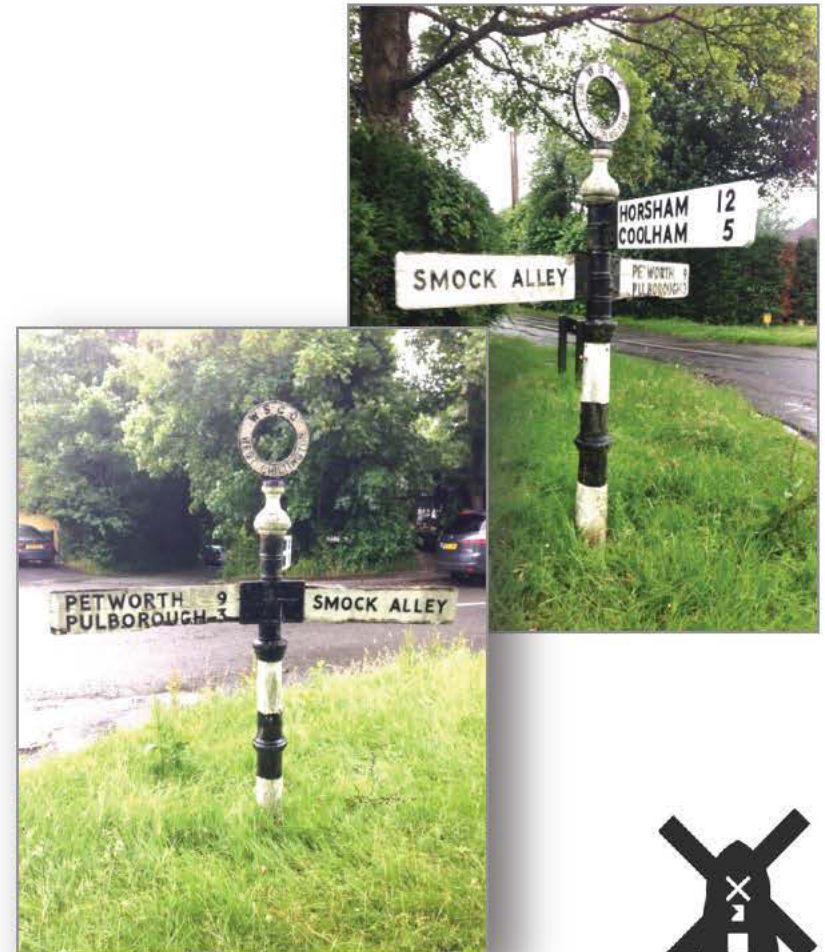
# #10

## Nytimber / The Common

TYPE Prewar Cast Iron  
BOARDS 3

BOARD	TEXT	DIMENSIONS (mm)	REMARKS
10.1	Coolham 5 Horsham 12	900 x 300	Sound - Repaint
10.2	Smock Alley	900 x 190	Rotten - Repair/Replace
10.3	Pulborough 3 Petworth 9	900 x 190	Rotten - Repair/Replace

Good original condition though some maintenance is needed to ensure the sign remains preserved. There is evidence of rust and some 16 coats of paint much of which needs to be blasted back before further repainting is attempted. Suggest removal of boards and errectsoda blast in situ. The ring Finial is 1930's design 'WEST CHILTINGTON'

Sign is well preserved and all the ironwork seems original and correct. Attention is required to preserve the sign, especially with regard to repainting of the iron work. Lead is undoubtedly present in the lower coats of pain hence caution needs to be taken. May be possible to soda blast in situ. Immediate action is needed in order to preserve this sign.

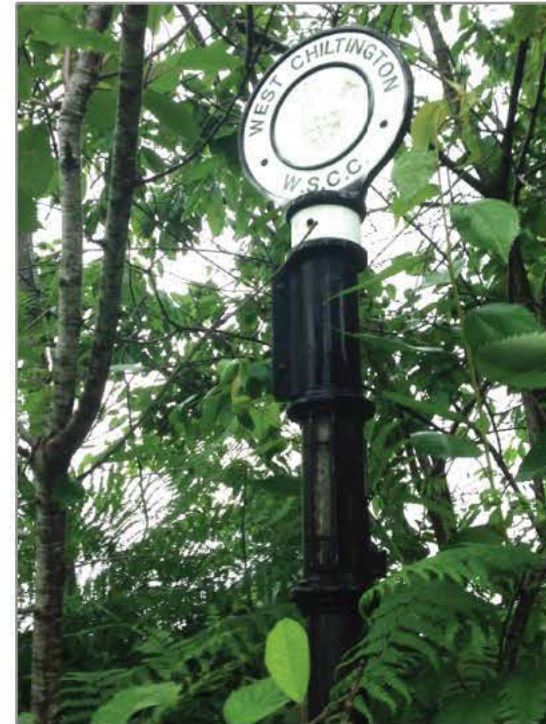
# #11

## Stream Lane / Gay Street

TYPE Pole Marker  
BOARDS 3

BOARD	TEXT	DIMENSIONS (mm)	REMARKS
11.1	Gay Street	900 x 200	Missing
11.2	Nutborne 1 Pulborough 2	900 x 200	Missing
11.3	W. Chiltington 1 Coolham 4	900 x 200	Missing

The original iron post has been replaced with a steel pole. The sign has been fitted with a modern aluminium cast finial with the county coat of arms printed on (this has now worn away)

Location of sign has overgrown considerably. All boards have broken off. Construction of sign not really intended for rural use. Needs replacement.

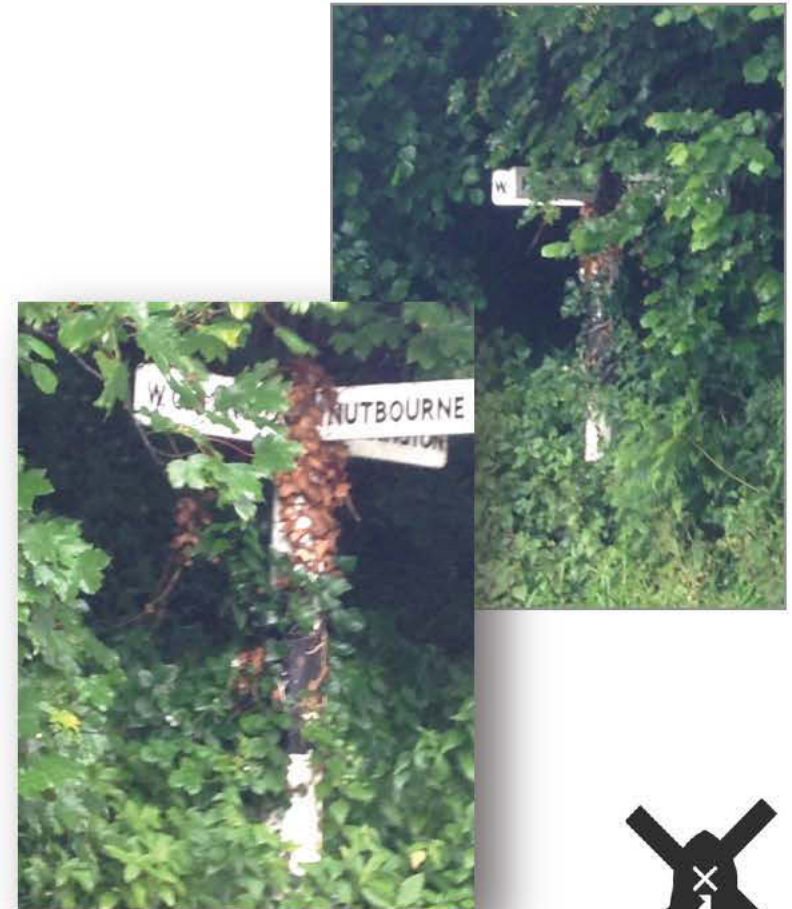
# #12

## Windmill

TYPE Oak Post (East Sussex)  
BOARDS 3

BOARD	TEXT	DIMENSIONS (mm)	REMARKS
12.1	W. Chiltington	700 x 180	Sound - Repaint
12.2	Nutborne	650 x 150	Sound - Repaint
12.3	Storrington	700 x 180	Sound - Repaint

None - Post is oak and is mostly sound however there are signs of rot at the base. The extent that the post is able to move indicates this rot may already be quite advanced. The mortice joints seem very solid and well sealed, though ivy growth has started to effect the join to the 'Nutborne' board. The cast iron top cap is missing.

The sign is greatly obscured by overhanging foliage (as evident in the pictures). Attention is required to reinforce the rotten base.

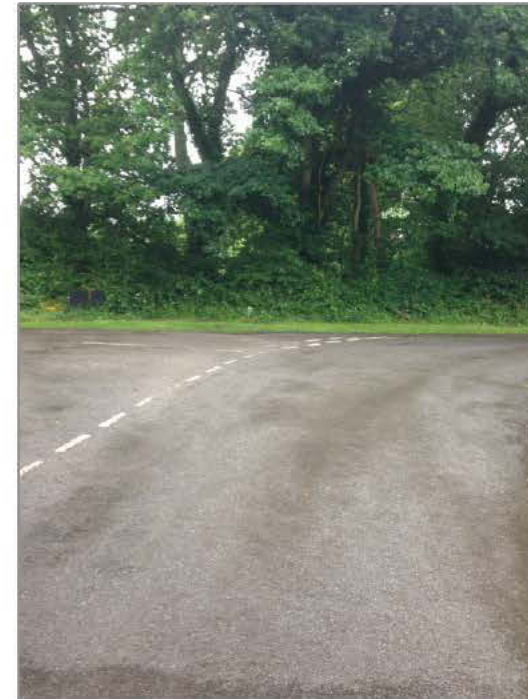
# #13

## Gay Street

TYPE Prewar Cast Iron  
(Missing)  
BOARDS 3

BOARD	TEXT	DIMENSIONS (mm)	REMARKS
13.1	W Chiltington 2 Gay Street	900 x 200	Missing
13.2	Adversane 2 North Heath	900 x 200	Missing
13.3	No Through Road	900 x 200	Missing

Missing

Location of previous sign (Looking East for Gay Street Ln)
